# Pitting Corrosion

Technical White Paper

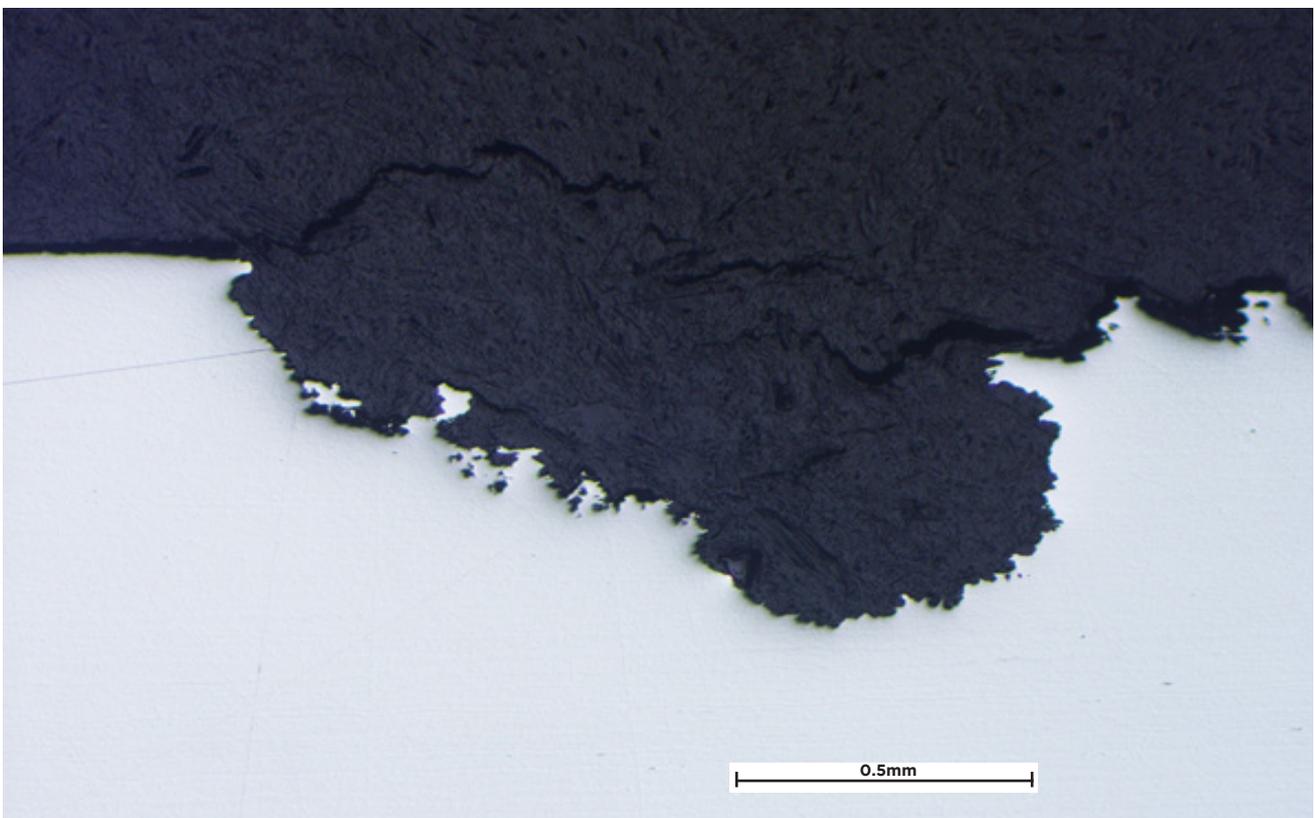
*Photomicrograph of a section through a shallow pit in an austenitic stainless steel.*

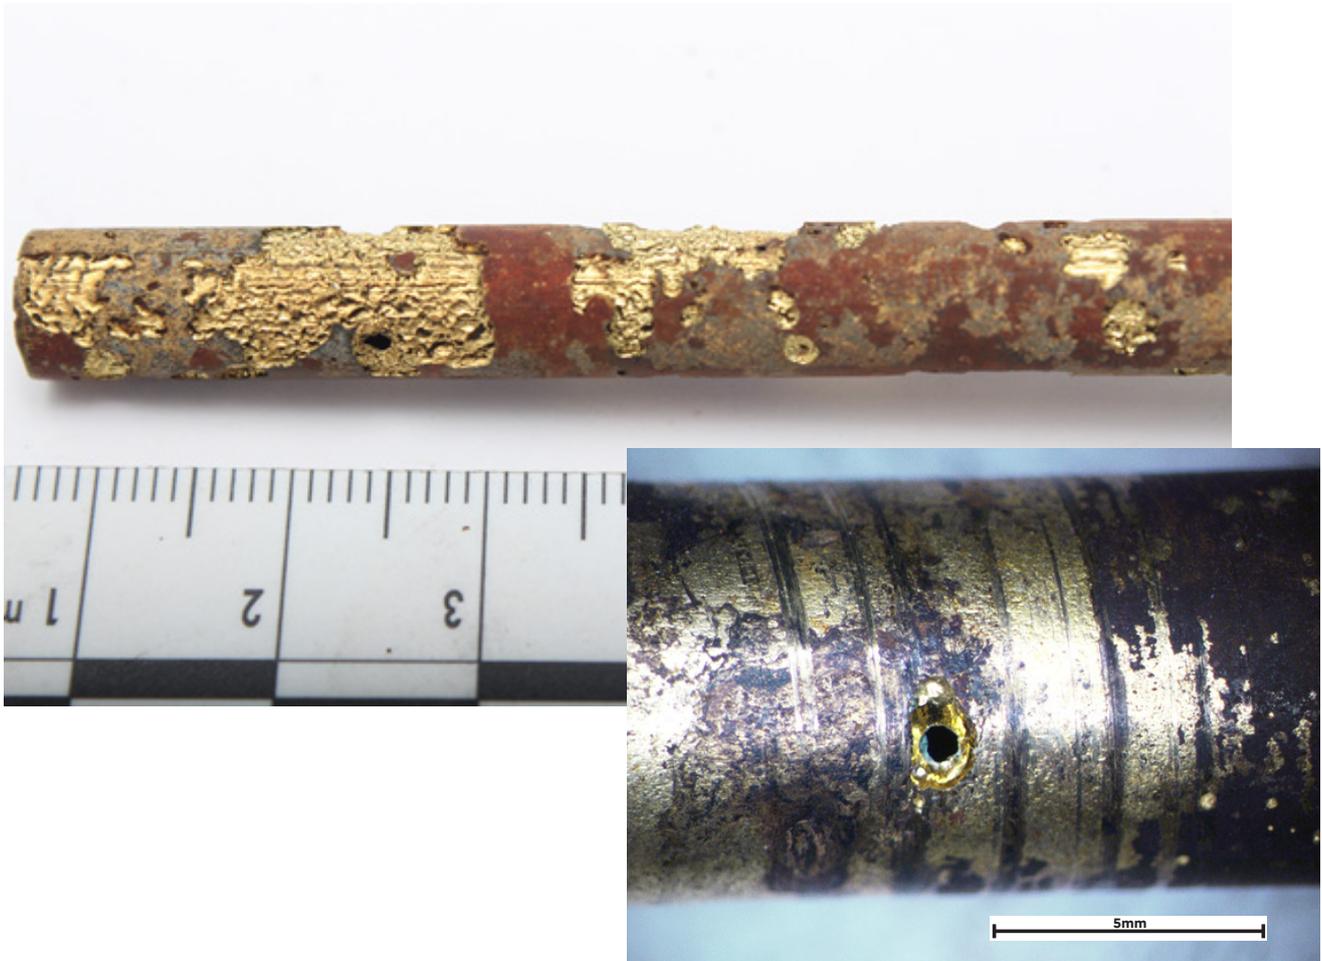
Brass fittings used in a hot water system for domestic use had started to fail some months after installation and commissioning of the system. These fittings had been used in other similar systems providing service as expected, with no issues. On investigation, the fittings were found to have suffered from varying degrees of pitting attack. The condition of the water was reported to have been variable with respect to dissolved iron and copper, and with pH excursions beyond the design parameters, becoming extremely alkali.

*Brass fitting used in a hot water system showing isolated and grouped pitting corrosion damage.*

The fittings also exhibited remnants of heavy scale which would be expected in a 'normal' environment. This scale develops naturally, following installation, with the rate of development slowing with time, and the scale then protects the underlying metal from further attack if the conditions of the water remain constant. The presence of this scale indicated that at installation, the conditions were indeed normal, but in time, these changed to one where the water became corrosive leading to the observed pitting. The client was then able to focus their attention on investigating the control and monitoring procedures used on the hot water system to avoid recurrence.

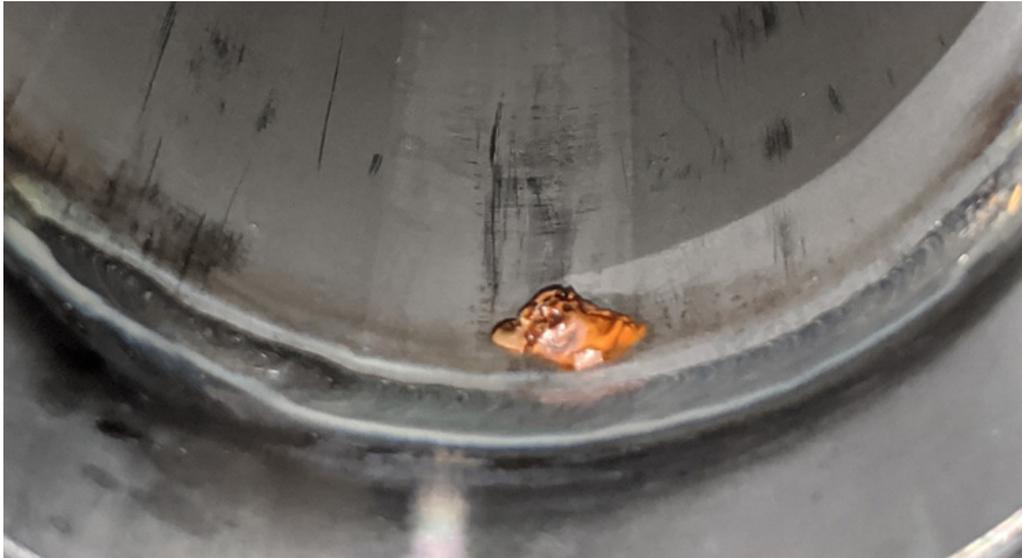
A 316 stainless steel pipework system was installed in a facility handling various soaps and cleaning agents. Extensive pipework systems had been manufactured on site by a welding contractor. A few weeks after installation and commissioning one of the systems started to show multiple leaks through 'pin holes' in the pipe walls and particularly in the vicinity of welds; none of the other systems were affected even though the materials and welding practices were the same. The affected system however, had been exposed to a different commissioning procedure using towns water, and product, with a short period of stagnation.

*Corrosion pustule at a weld heat affected zone.*

Investigation identified pitting corrosion that had developed on the inside of the pipework. Pustules of corrosion deposits were observed to be associated with heat tints developed at weld heat affected zones, in a manner consistent with microbial action (see white paper on microbial induced corrosion (MIC)). However, although the initiator was microbial activity, the process of pitting corrosion followed the same mechanism as any other pitting corrosion.
