STRESS CORROSION CRACKING (SCC)

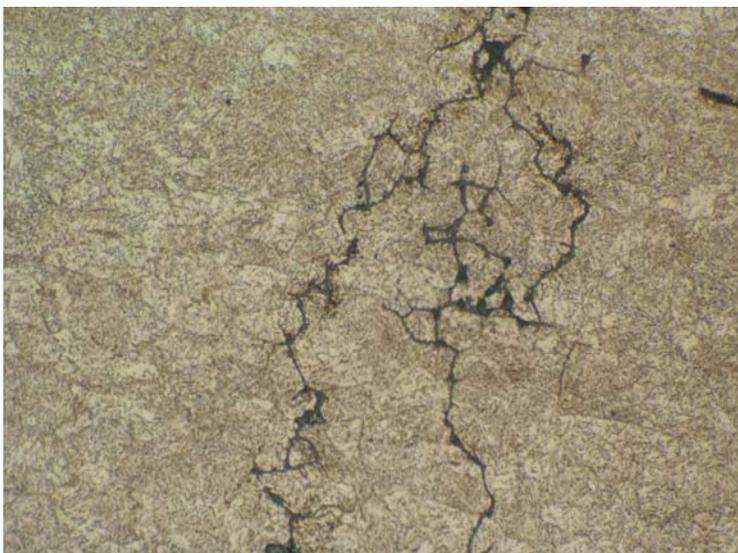
SCC in hardened and tempered steel, here cracks are intergranular due to nitrates.

The valve between vessels 5 and 6 was in poor condition, requiring it to be sprayed with water from the local river to keep it cool. But ferritic steel + heat + nitrate is one of those potentially nasty SCC conditions mentioned above (an example of cracking due to this mechanism is shown to the left). Due to the combination of river water and heat, nitrates in the water from fertiliser run-off from agriculture concentrated up and caused stress corrosion cracking of vessel 5. Fortunately, the early sign was leakage through the cracks, which was noticed, and vessel 5 was taken out of service. To continue manufacturing, vessel 4 was connected to vessel 6 with a temporary pipe but in haste, this was poorly positioned and supported.

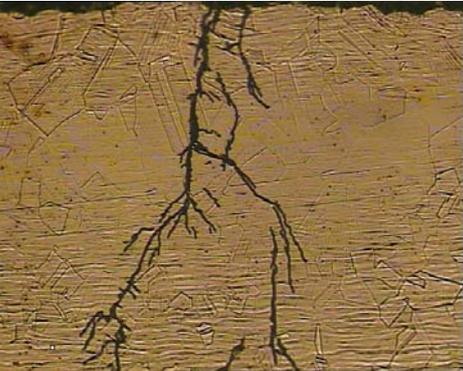
Transgranular cracking in an austenitic stainless steel.

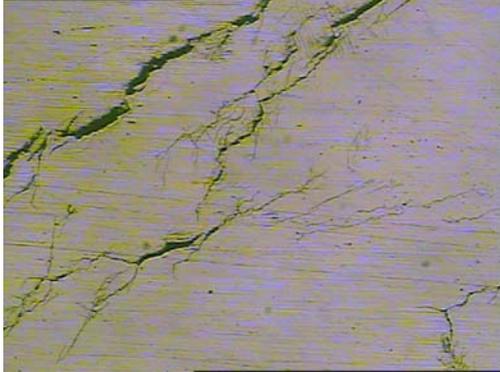
The Al-12%Si develops two distinct phases. Other alloys that produce distinct phases, like Al-Mg alloys that can develop continuous precipitates of Mg_5Al_8 generate anodic cells with respect to the matrix. This induces intergranular SCC in chloride solutions.

Other alloys have a narrow freezing range, and develop less coring. One such alloy, aluminium containing 12% silicon, has a much narrower freezing range, so it can be cast with thinner cross section without the risk of shrinkage. This property enabled it to form the basis of very successful Cosworth racing engines in the 1980's partly because sound engine blocks could be cast in thinner sections, allowing for greater efficiency and better power to weight ratio. It probably follows that alloys with a narrow freezing range are less likely to be susceptible to intergranular SCC mechanisms.

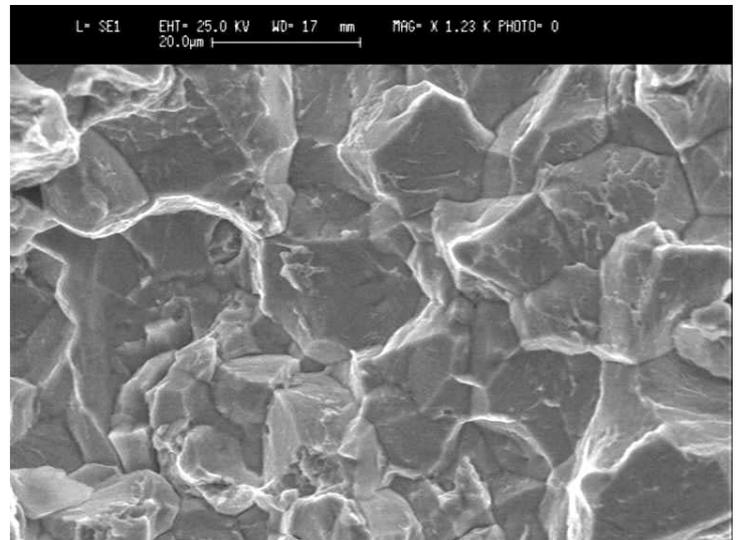
Intergranular SCC leaving grains showing crevices where they are being wedged apart

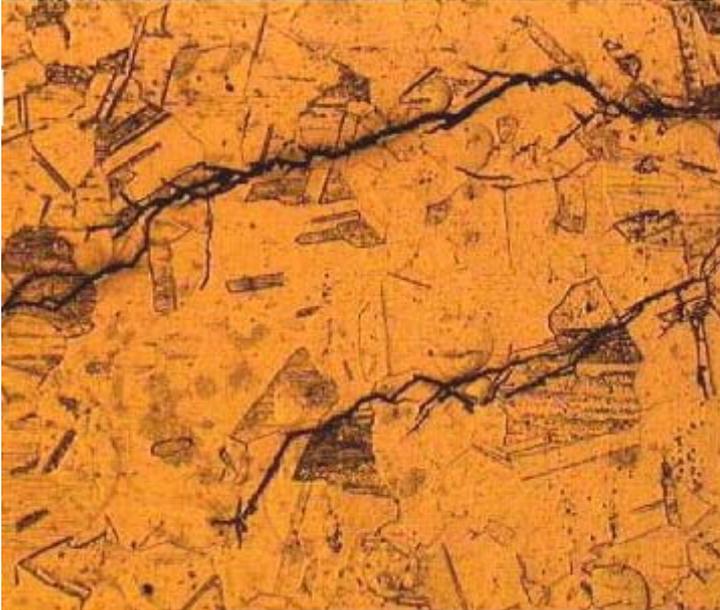
Transgranular SCC in brass
