Corrosion Fatigue

Technical White Paper

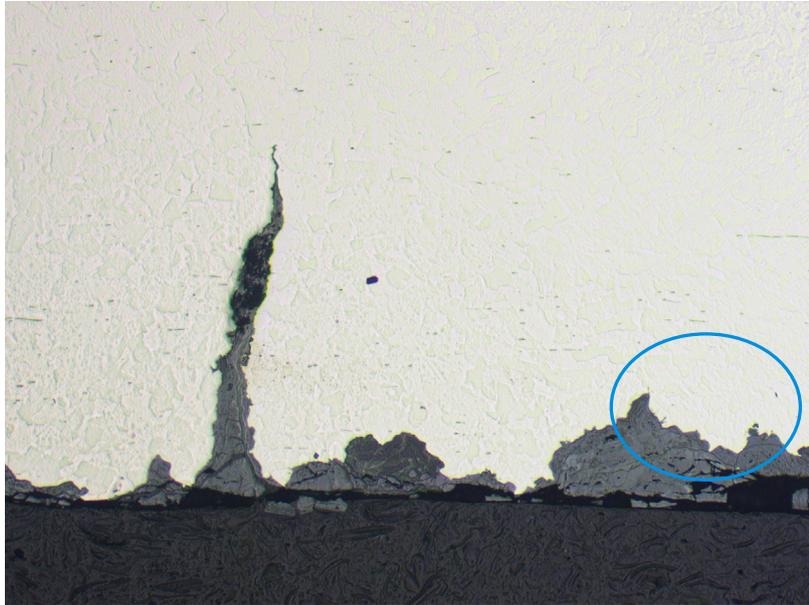
Some metals such as steel, exhibit a fatigue limit, which is a stress amplitude (fluctuating stress), below which fatigue will not occur, but the presence of corrosion eliminates this limit and the steel will eventually develop fatigue cracks. Metals such as aluminium and stainless steels do not exhibit fatigue limits and will then eventually initiate fatigue cracks when exposed to cyclic tensile stresses. Furthermore, corrosion can lead to small pits at the surface and these act as stress concentrations, driving cracking initiation, and pits are often observed at crack initiation sites as shown in the image below. This shows the surface of a steel shaft with a corrosion fatigue crack and pits, some of which have early stage fatigue cracks starting to propagate away from the base of the pit (circled).

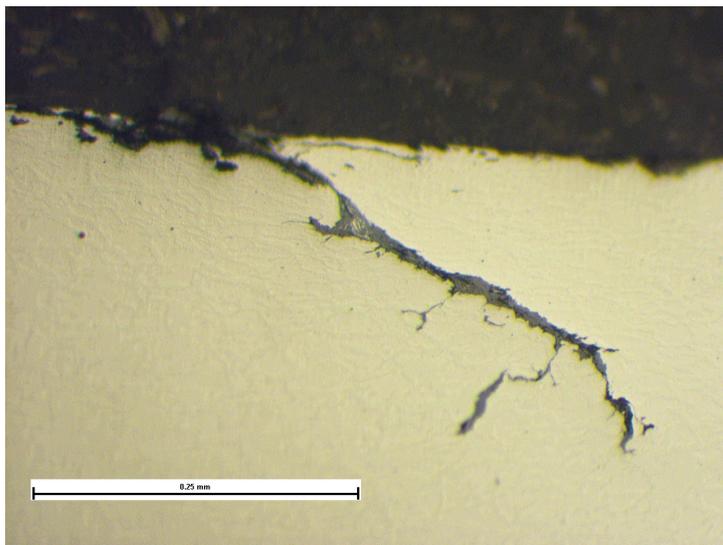
During microscopic examination of sections cut through cracks, corrosion fatigue will often be identified by corrosion attack/deposits, and occasionally minor side-branching of the cracks as shown below.

This was caused by heavy fretting on the shaft of a water pump. Fretting had caused plastic deformation and wear of the shaft surface and combined with corrosion, had initiated fatigue cracks, which is not uncommon on fretted surfaces. Due to the cyclic stress from operation of the pump, and the corrosive environment, corrosion fatigue cracks had propagated through the shaft leading to its complete fracture.

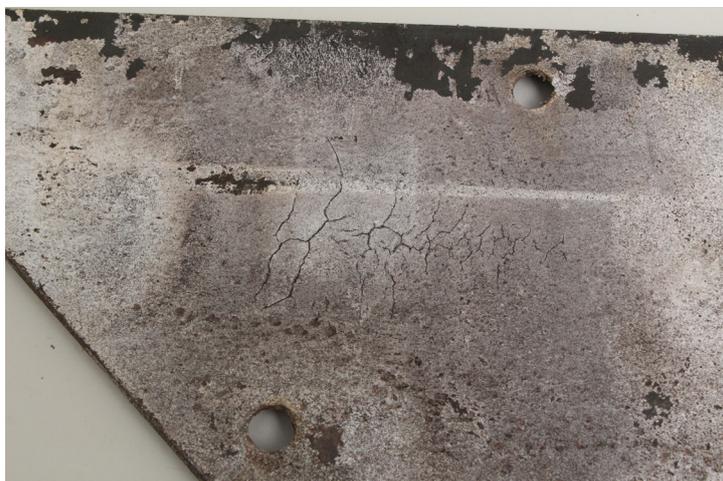
The image below shows the heavy corrosion fatigue attack of the underside of a track plate used for an amusement park ride.

Due to the design of the track, the track support allowed for its flexure, inputting a cyclic stress from bending, with the underside of the track plate in tension. In addition, the underside of the track plate remained wet for prolonged periods of time, through contact with the main structure of the ride, creating a crevice and driving corrosion. The two images below show the severity of the corrosion attack on the underside, widening of the cracks at the surface, secondary cracks, and corrosion pits.

The cracks were only discovered during routine non-destructive testing (NDT) using magnetic particle inspection (MPI) of the running face of the track plate which identified a network of cracks on the surface, which had propagated through the full thickness of the plates. The extent of the cracking was severe, but isolated, with the body of the track plate which, at the point of inspection, had sufficient structural integrity to have remained serviceable. However, the condition of the track plates was clearly poor and failure by complete fracture could be considered to be 'imminent', with the implications of this on an amusement park ride.

If sufficient changes cannot be made to reduce the probability for corrosion fatigue cracking, regular NDT may be a solution to monitor the condition. In the example of the track plate used in the amusement park ride, the routine NDT clearly identified the cracks before a catastrophic failure occurred, although in this example, the cracks were well advanced to a point where complete fracture could have occurred in a relatively short but unpredictable time. In this case, the inspection periodicity should be significantly reduced.

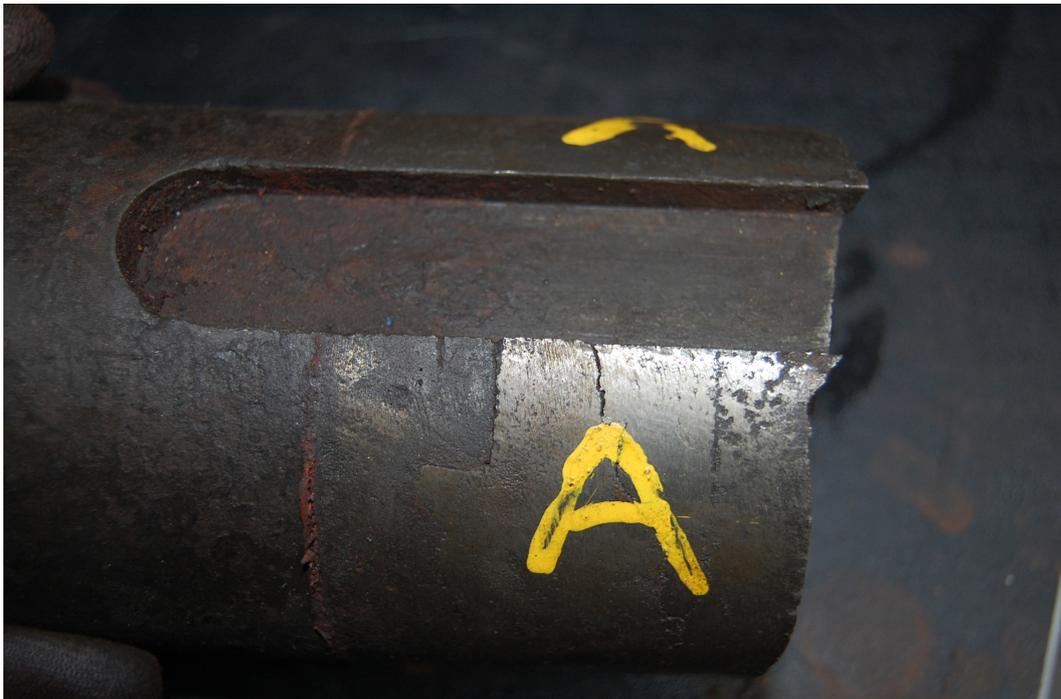
Another example is the failure of a carbon steel shaft that was used in a pump application. The image below shows the fracture and general condition of the shaft, being heavily corroded.

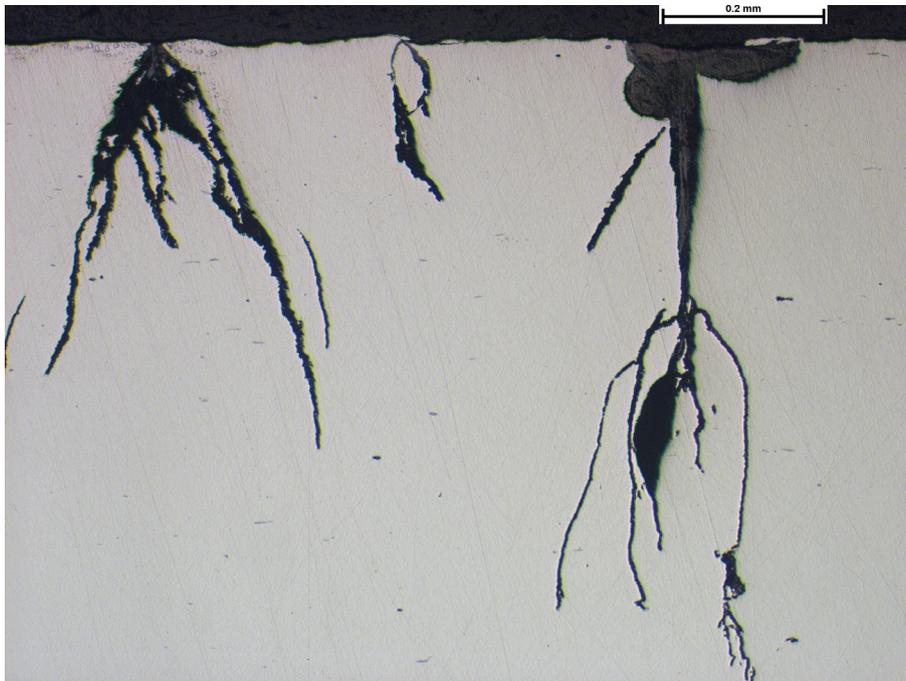
The fracture face exhibited features indicative of fatigue and when microscopic examination of sections through the surface of the shaft was carried out, additional branched cracks were observed as shown below.

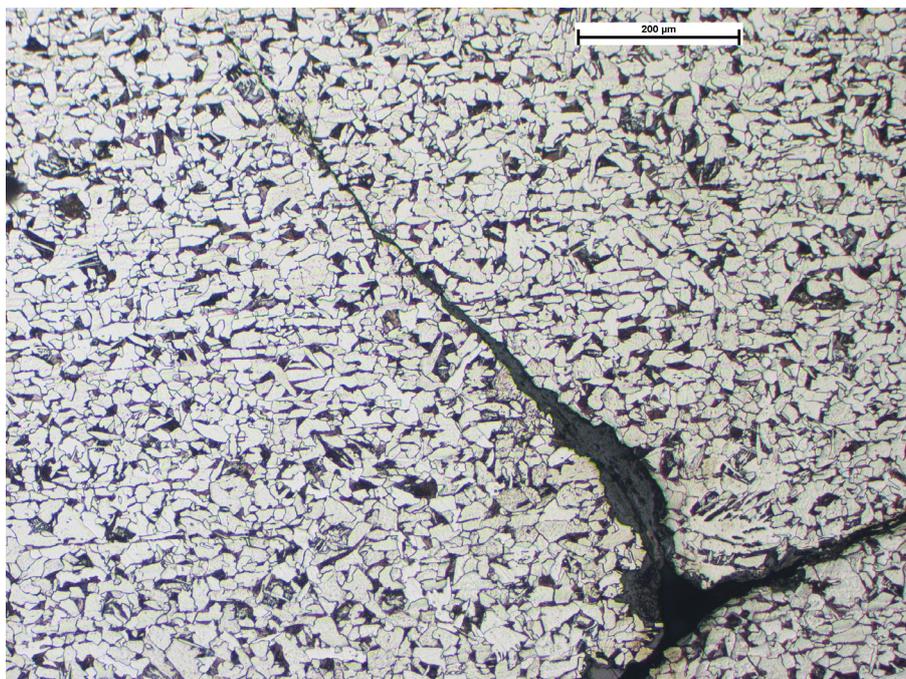
In the etched condition, the cracks were observed to have propagated in a transgranular manner, as expected, through the microstructure that consisted of grains of pearlite in a ferrite matrix shown below.
